TEMPERATURE RISE OF COLD-FORMED STEEL BUILT-UP BACK-TO-BACK COLUMN UNDER STANDARD FIRE

Fadhluhartini Muftah^{a*}, Mohd Syahrul Hisyam Mohd Sani^a, Shahrin Mohammad^b, Shek Poi Ngian^b, Mahmood Md Tahir^b

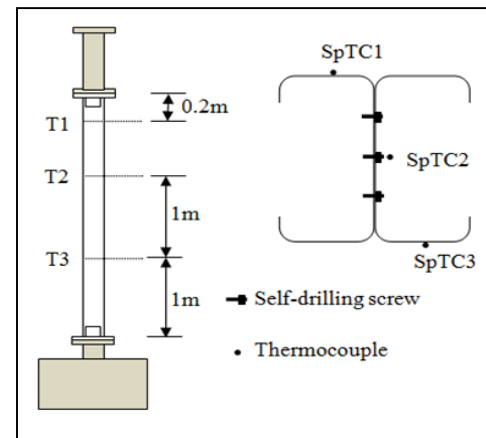
Figure 1 Location of thermocouple on the column

Type K. Table 1 provides the notation for the thermocouple used in this study. Based on the recommendations of BS EN 13381-4:2013 (E) [14], the thermocouple was positioned along the column height as shown in Figure 1. It can be observed that thermocouple was attached to the column's section at the flange and the web. Besides that, a static test of the built-up BTB column was conducted at ambient temperature to determine the capacity of the column. According to this static test, a load ratio known as the degree of utilization is considered to evaluate the temperature rise in the column and finally determine the fire resistance of the column. During the fire test, the column was loaded at a constant load level as in real structure application. The load was left for constant until reach stable condition for 10.0 minutes before the fire induced. Then, fire was blown to the column inside the furnace until the column failed. The temperature rise in the column was monitored. The column was loaded using a hydraulic jack loading system with maximum loading of 1000.0 kN. The load applied was at 0.25 kN/s for both ambient and fire condition.

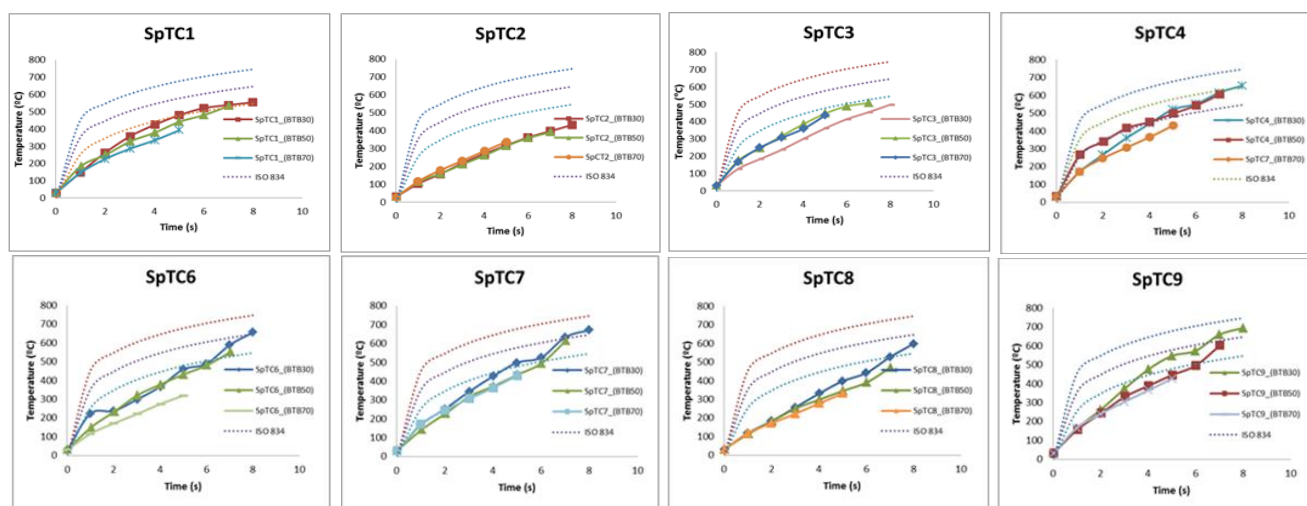
Figure 4 Temperature rise in built-up back to back column

Figure 4 shows the recorded thermocouple at each station on the BTB column for different degrees of utilisation. Only eight out of nine thermocouples give reliable results. This is the cause of an error such as positive, negative conductor touch to each other due to fracture of ceramic that cover both conductors due to impact during column failure in previous test. Thermocouples located at 200.0 mm from top support and loading is known as SpTC1-SpTC3. The rise of temperature at this location is below the standard fire ISO 834 [16] for all degrees of utilisation until the column fails. The temperature recorded for SpTC2 that located at the column web is lower than the SpTC1 and SpTC3 that located on the flange respectively. The same temperature behaviour of built-up I-section was found in the study conducted by [13] which the temperature at the web registered lower temperatures than the ones of the flanges. This might explain that the greater thickness of the web and the thermal conductance between the two CFS profiles [13]. This behaviour also found for all thermocouple at other level in the column. SpTC4 and SpTC6 is thermocouple placed at 1 meter from top of column flanges respectively. It was found that rise of temperature is faster compared to the top side. The rates of temperature rise are almost similar for SpTC4 and SpTC6. SpTC4 and SpTC6 for 70.0 % degree of utilisation have risen up to ISO 843 [16] fire curve at failure while for 30.0 % degree of utilisation, the column was failed at lower temperature. SpTC7-SpTC9 recorded the temperature for lowest side at 2.0 m from loading. It was observed that the SpTC7 and SpTC9 also recorded higher value in that level. In addition, the values in this level are slightly higher to the thermocouple at the middle level. The rate of temperature rise was also similar for different degrees of utilisation. It can be concluded that the rate of temperature rise of the BTB CFS column is constant for CFS and in-dependent to the degree of utilisation.

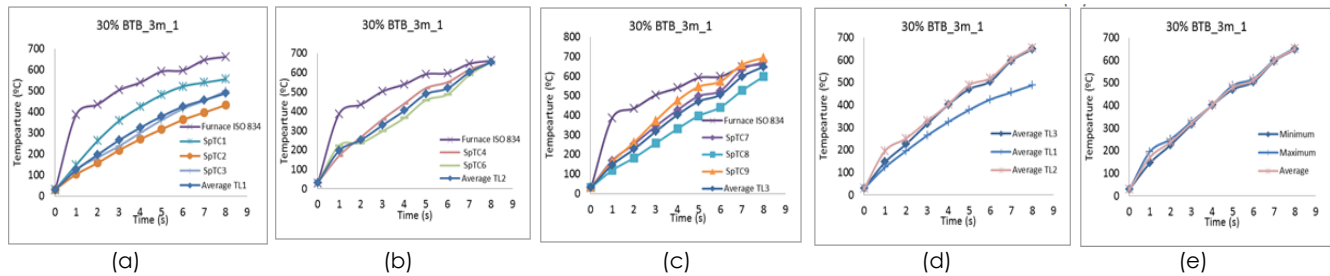
Figure 5 Evaluation of mean temperature along the column for 30.0 % degree of utilisation

Figures 5-7 show the rise of temperature recorded on a BTB column fewer than 30.0 %, 50.0 % and 70.0 % service load which were exposed to standard fire. All of the columns had the same behaviour of temperature rise where the upper side of thermocouple registered lower temperature until the columns' failure. This might be caused by the thermocouple was located nearer to the ceramic fibre which supported the column end. The heat was shielded by a ceramic fibre that restricted the conductance of heat to this position. Thus, it was expected that the failure of 30.0 % degree of utilisation column failed the temperature increase in the column. Meanwhile, Figures 7(a)-(c) show the column temperatures in the BTB column. In the meantime, the middle and bottom level recorded temperatures that approached the standard ISO fire. The columns failed as all thermocouple at the middle level reached the temperature of ISO fire. The column with a 50.0 % degree of utilisation showed that the bottom side of the column had reached the temperature of ISO fire. Meanwhile, the column with 70.0 % degrees of utilisation were recorded none of the temperature had reached the ISO temperature at failure. This temperature behaviour was due to the high load applied, which caused the column to have large deformations and had reduced its stiffness faster when heat induced. According to the temperature recorded, the column with the lower degree of utilisation failed due the temperature of the column had reached the standard fire. For the moment, the columns with a higher degree of

The evaluation of mean temperature along the column was calculated by using the weighted area methods in which the temperature recorded were multiplied to the area of the column surface [13]. It was observed that the web temperature was lower than the flange temperature and average value lead to the lowest average value. Figures 5-7 (d) show the average value at each thermocouple level. It was found that all degrees of utilization column had recorded a non-uniform temperature at its cross-section for all different levels. The column with a 30.0 % degree of utilisation had a higher temperature at TL3 and TL2, while columns with 50.0 % and 70.0 % degree of utilisation had a higher temperature for TL2. This might be caused by T1's location was nearer to the column supported with ceramic fibre which caused it to register a lower temperature. Hence, it was ideal to account T2 and T3 to get the mean temperature in the column. Figure 5-7 (e) shows the minimum, maximum, and average values of temperature. While the columns with 30.0 % and 70.0 % degree of utilisation obtained close results with the temperature, hence the average value is used. On the other hand, the columns with a 50.0 % degree of utilisation, had a big difference in the value of temperature, thus, the minimum value is used. Table 2 tabulates the mean temperature of the column.

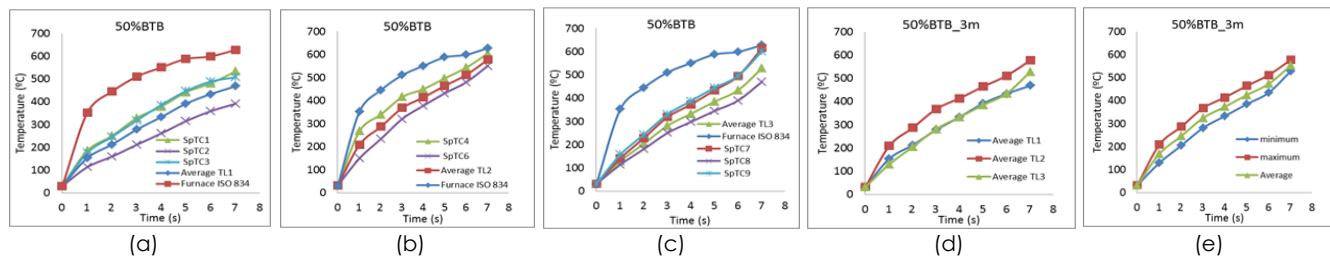
Figure 6 Evaluation of mean temperature along the column for 50.0 % degree of utilisation

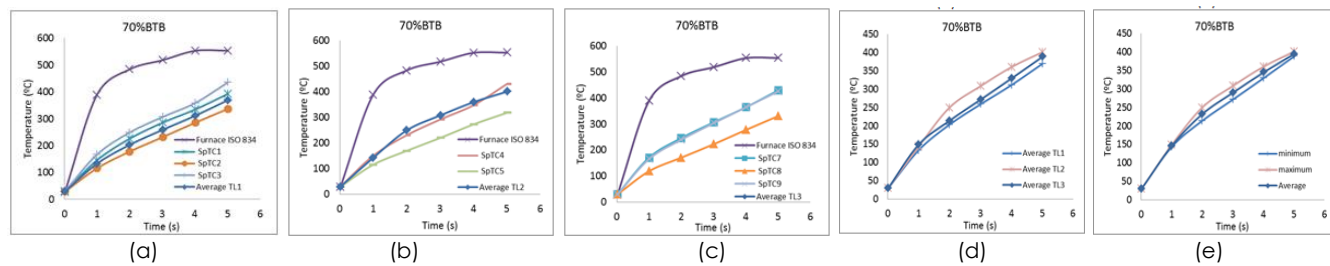
Figure 7 Evaluation of mean temperature along the column for 70.0 % degree of utilisation
